PIC32MZ Graphics (DA) Family

PIC32MZ Graphics (DA) Family Silicon Errata and Data Sheet Clarification

The PIC32MZ Graphics (DA) family devices that you have received conform functionally to the current Device Data Sheet (DS60001361E), except for the anomalies described in this document.

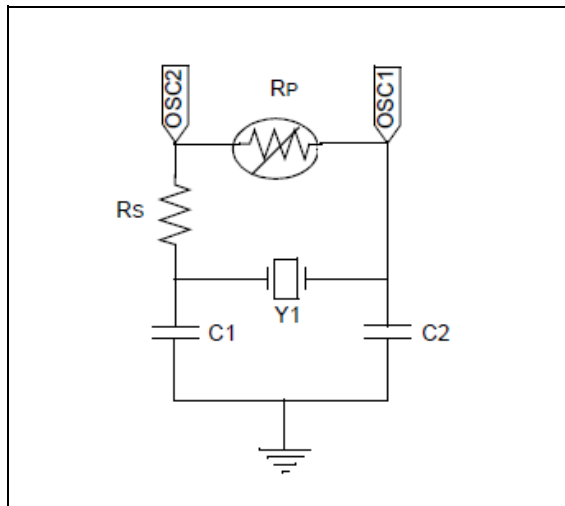
FIGURE 1: Posc CRYSTAL CIRCUIT

The POSC has been tested in a normal power-up sequence and supports specific crystal operation.

The Primary Oscillator (Posc) has been characterized to operate at 8 MHz and 12 MHz when the circuit shown in Figure 1 is implemented, and the operating conditions listed in Table 3 are met.

TABLE 3: CRYSTAL SPECIFICATION

Crystal Frequency (See Note 1)	Series Resistor Rs	Posc Gain Setting POSCGAIN<1:0> (DEVCFG0<20:19>	Posc Boost Setting POSCBOOST (DEVCFG0<21>
8 MHz	2 kΩ	'0b00 (GAIN_0)	'0b1
12 MHz	1 kΩ	'0b00 (GAIN_0)	'0b1

Note 1: Using any other crystal frequency will require special component selection and characterization.

2: A parallel register (Rp) should not be used to increase the gain of the Posc.

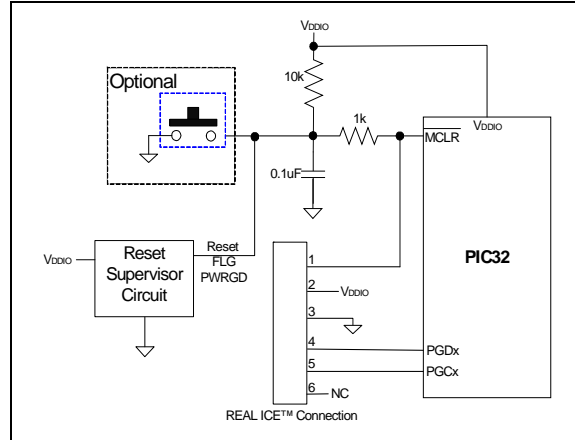
FIGURE 2: EXTERNAL RESET CIRCUIT

A system Reset is not generated on a BOR event ($V_{PORIO} < V_{DDIO} < V_{BORIO}$). This will stop system clocks with all the I/O pin functions frozen in the present state until either V_{DDIO} falls to V_{PORIO} or $V_{DDIO} > V_{BORIO}$.

Reset device using a \overline{MCLR} pin through an external reset supervisor/monitor is shown in Figure 2. Set the SMCLR (DEVCFG2<15>) configuration bit to '0', which makes the \overline{MCLR} to act as a POR Reset instead of a normal system reset.

Table 4 and Table 5 provide a list of external Reset supervisor and regulators with built in Reset supervisors that can be used.

When selecting an external supervisor other than the ones provided in Table 4 and Table 5, the following requirements must be taken into consideration:

- Minimum Reset trip voltage of the external supervisor should be $V_{BORIO} (Max)+0.5V$.
- The external reset supervisor/LDO output going to \overline{MCLR} should have an open drain output to not interfere with the MPLAB programming/debug tools.

When this work around is implemented, the minimum V_{DDIO} operating voltage of the application needs to be above the reset supervisor maximum trip voltage + 0.2V, where 0.2V compensates for variation in the external reset supervisor voltage.
