Silicon identification

This document applies to the part numbers of STM32F071x8/xB devices listed in [Table 1](#) and their silicon revisions shown in [Table 2](#).

[Section 1](#) gives a summary and [Section 2](#) a description of device limitations, with respect to the device datasheet and reference manual RM0091.

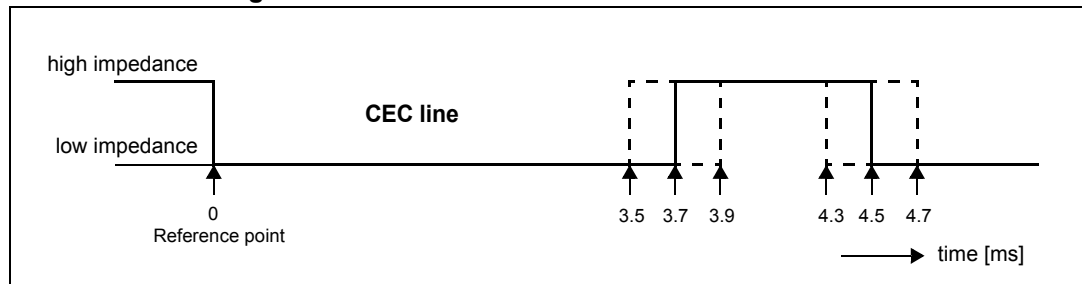
Figure 1. HDMI-CEC start bit format with tolerances

This failure is unlikely to happen as the CEC start bit corruption by another device can only occur if that device does not respect the CEC communication protocol.

The start bit timing standard tolerances are shown in [Figure 1](#). The start bit is initiated by the device by driving the CEC line low (reference point). After 3.7 ms, the device releases the CEC line and starts checking its level. The following conditions must be met for the start bit to be valid:

If one of these conditions is not met, the transmission is aborted and never automatically retried. No error flag is set and the TXSOM (Tx Start Of Message) bit is not cleared.

A way to work this limitation around is for the system-level CEC application software to start a time-out counter when setting TXSOM bit and stop it upon TXBR or TXEND event. In case of time-out, the HDMI-CEC functional block is disabled then enabled, by setting the CECEN bit in CEC_CR register to 0 then to 1. This clears the TXSOM bit.
